The Journey of an 1800 Novice

BY SCOTT PINSKY

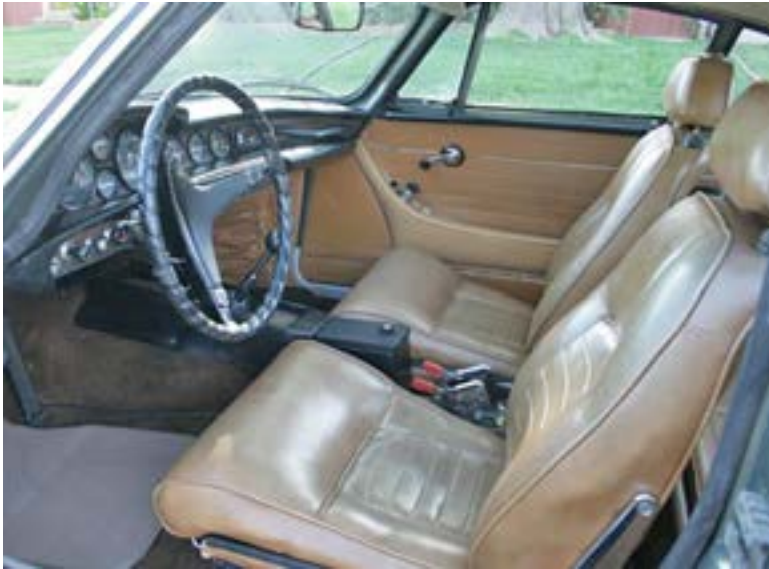
The interior was the immediate weakness I discovered when the car arrived: sagging seats, cracked dash, peeling faux-wood decals, and pungent carpets.

The works! I promptly embarked on what was supposed to be a quick interior refurb, but which—once the seats and carpets were out—became a full-bore cockpit project.

Once I got going on this job, I decided to do it all: new seats, seat webbing, carpets, headliner, rear seat-back, interior panels, armrests, etc. This degree of involvement allowed me to inspect the floorboards and overall condition of the cabin structure, which I discovered was very good for a car of this age.

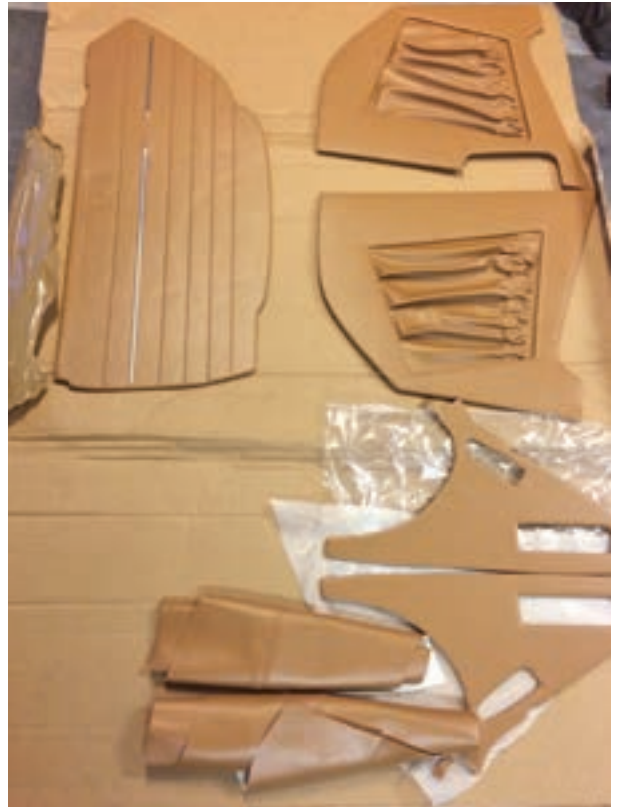
The planned quick interior refurb became a complete restoration and I ordered the works.

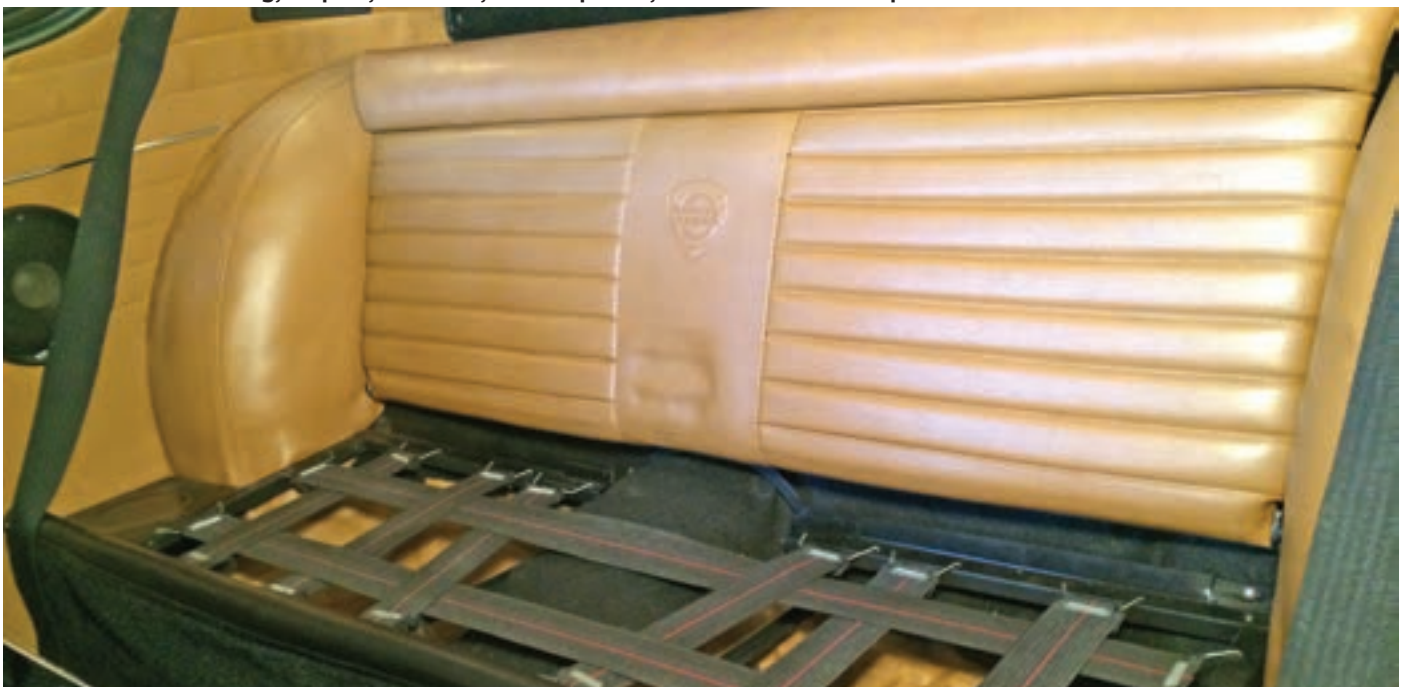
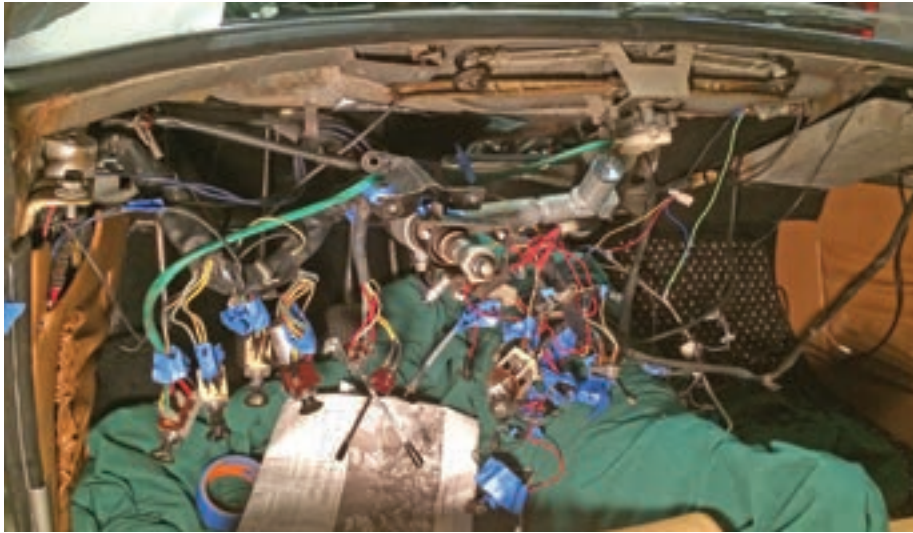
Seat covers and webbing, carpets, headliner, interior panels, and armrests were replaced.

The dash came out easily enough, but I needed some help to get it back together.

Several of the gauges went out for recalibration and cleaning and then all the switches and gauges were mounted while the dash was still on the bench. Finally, I re-installed the whole shebang into position. Reconnecting ▶

everything was the tricky part and I ended up needing to enlist some help. Luckily, I was directed to Dan Stone, a superb Bay Area electrical specialist, who came to my rescue and made a trip over to my garage to right the jumble I had created.

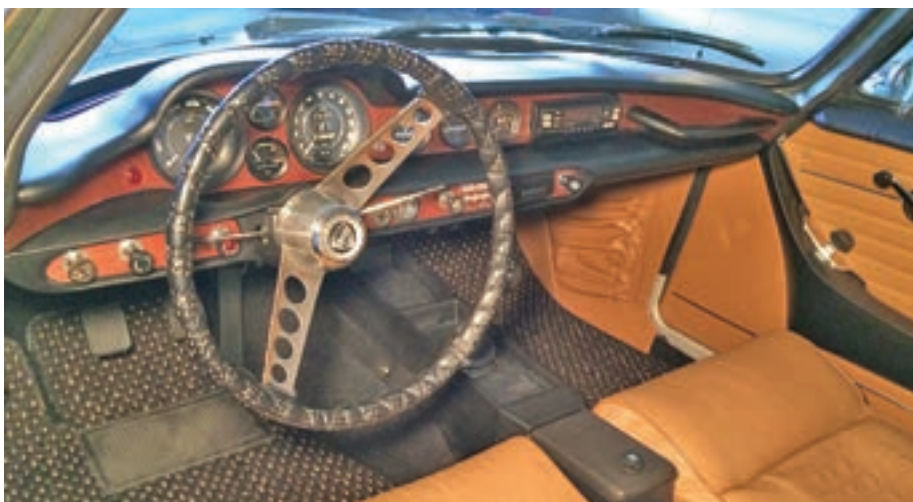
I decided to replace the stock decal faces with actual wood veneer. It was relatively easy, sand, and seal.

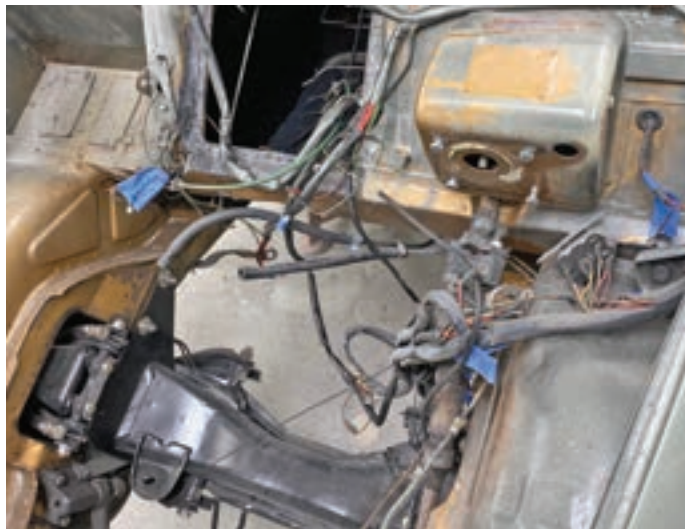
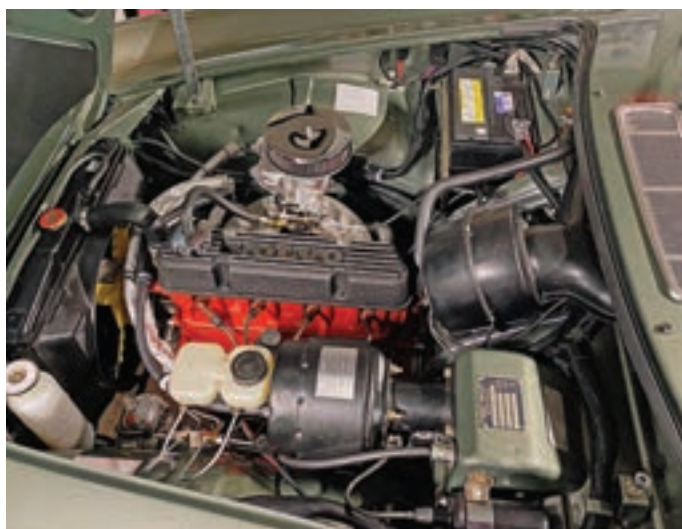
When we repainted the car, we decided to do the engine bay as well. With the motor out, its horrific state became fully apparent.

At this point, we pulled everything else we could out of the bay and got ready for paint. With the motor out, the bay's horrific state became fully apparent. I chose Andy Schank in Richmond, Calif. for the paint and bodywork. Andy has years of experience with vintage cars of this type, especially Alfa Romeos. He was willing to work with me on the few body modifications I wanted to make, which seemed minor to me at the time. Inevitably they became more complex in their

execution. For example, I decided to nix the four clunky side-marker lights as well as the front bumper. I also decided to eliminate the side trim along the fender and door. Little did I know the amount of welding I was committing Andy to, but he was behind me all the way. He also identified and tackled a few rust spots and body dings near the ground and worked it all into a good-as-new body with terrific lines as well as a pristine engine bay. Also, Andy's fine work was accomplished in under four weeks—a fraction of the time I've had other shops take to complete less complex projects. My hat off to him!

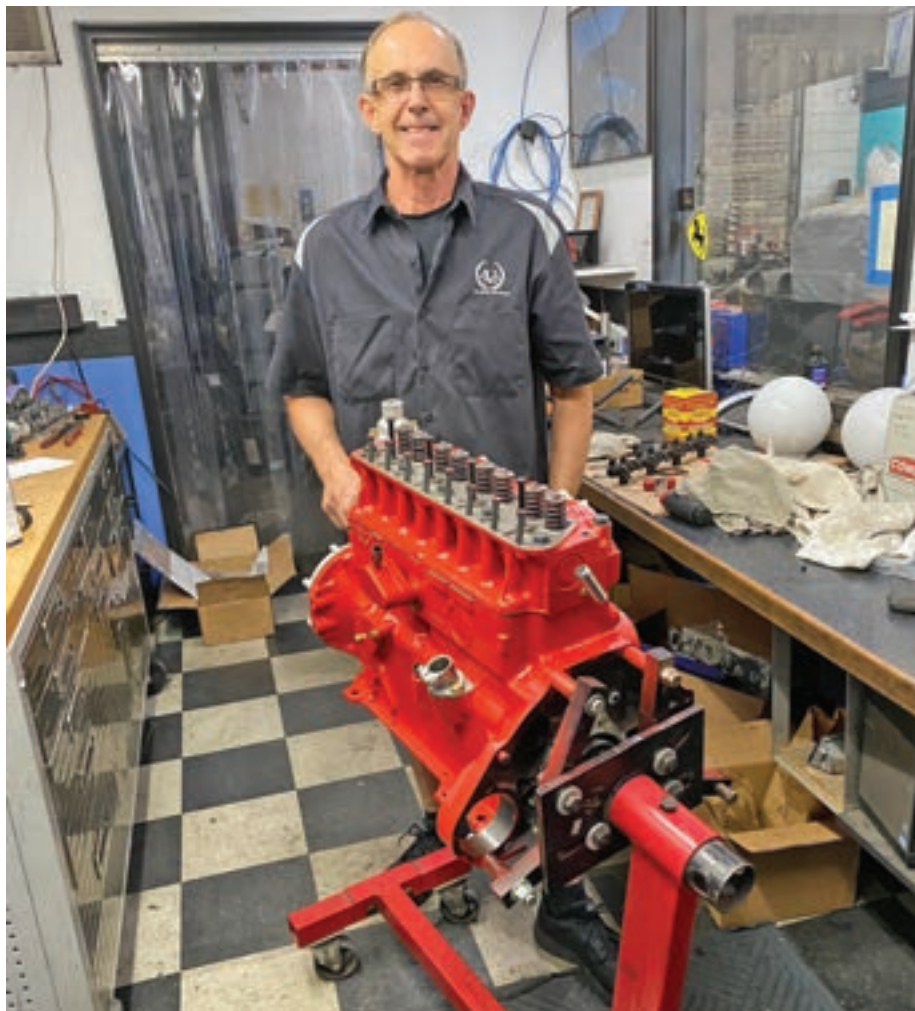
Robert Marcello, owner of Sacramento Volvo Service, and his team rebuilt the engine, including replacing the cracked head. They also made a number of improvements, such as upgrading the stock Bosch D-Jetronic fuel injection to a Holley Sniper EFI system.

Robert and his team began by pulling the engine, whereupon he immediately identified serious issues with the cylinders and pistons caused by faulty valves, liners, etc. The head also had a crack that turned out to be irreparable. Fortunately, the block was in decent enough shape that it could be sent out and ported and polished to accommodate available new internal hardware. Due to the cracked head, Robert elected to obtain a reconditioned B20B head (9.5:1 compression) and perfecting it. He spent 8-10 hours porting and polishing the runners, which added to the new-found torque the motor is now capable of creating.

In addition to a new set of headers, Robert suggested I consider replacing the stock fuel delivery system with a Holley Sniper EFI system. This is a setup he has had success with before on the 1800, so I was not concerned about going down some rabbit hole of untested modification. I procured the unit, which is computerized with self-tuning software, and Robert set it all up. Since we were at it, a new radiator, overflow bottle, starter, water pump, fuel pump, battery, and heater valve were also installed. The brake lines and junctions were cleaned and polished and all wiring was cleaned up or replaced, then wrapped. The majority of the stock parts were supplied by the knowledgeable and ever-helpful Lennart Johansson of VP Autoparts.
